TS-PIC- 90900
February 1991

EPA Site Analysis
Chemsol Site
Piscataway, New Jersey

Site Analysis
Chemsol Site
Piscataway, New Jersey

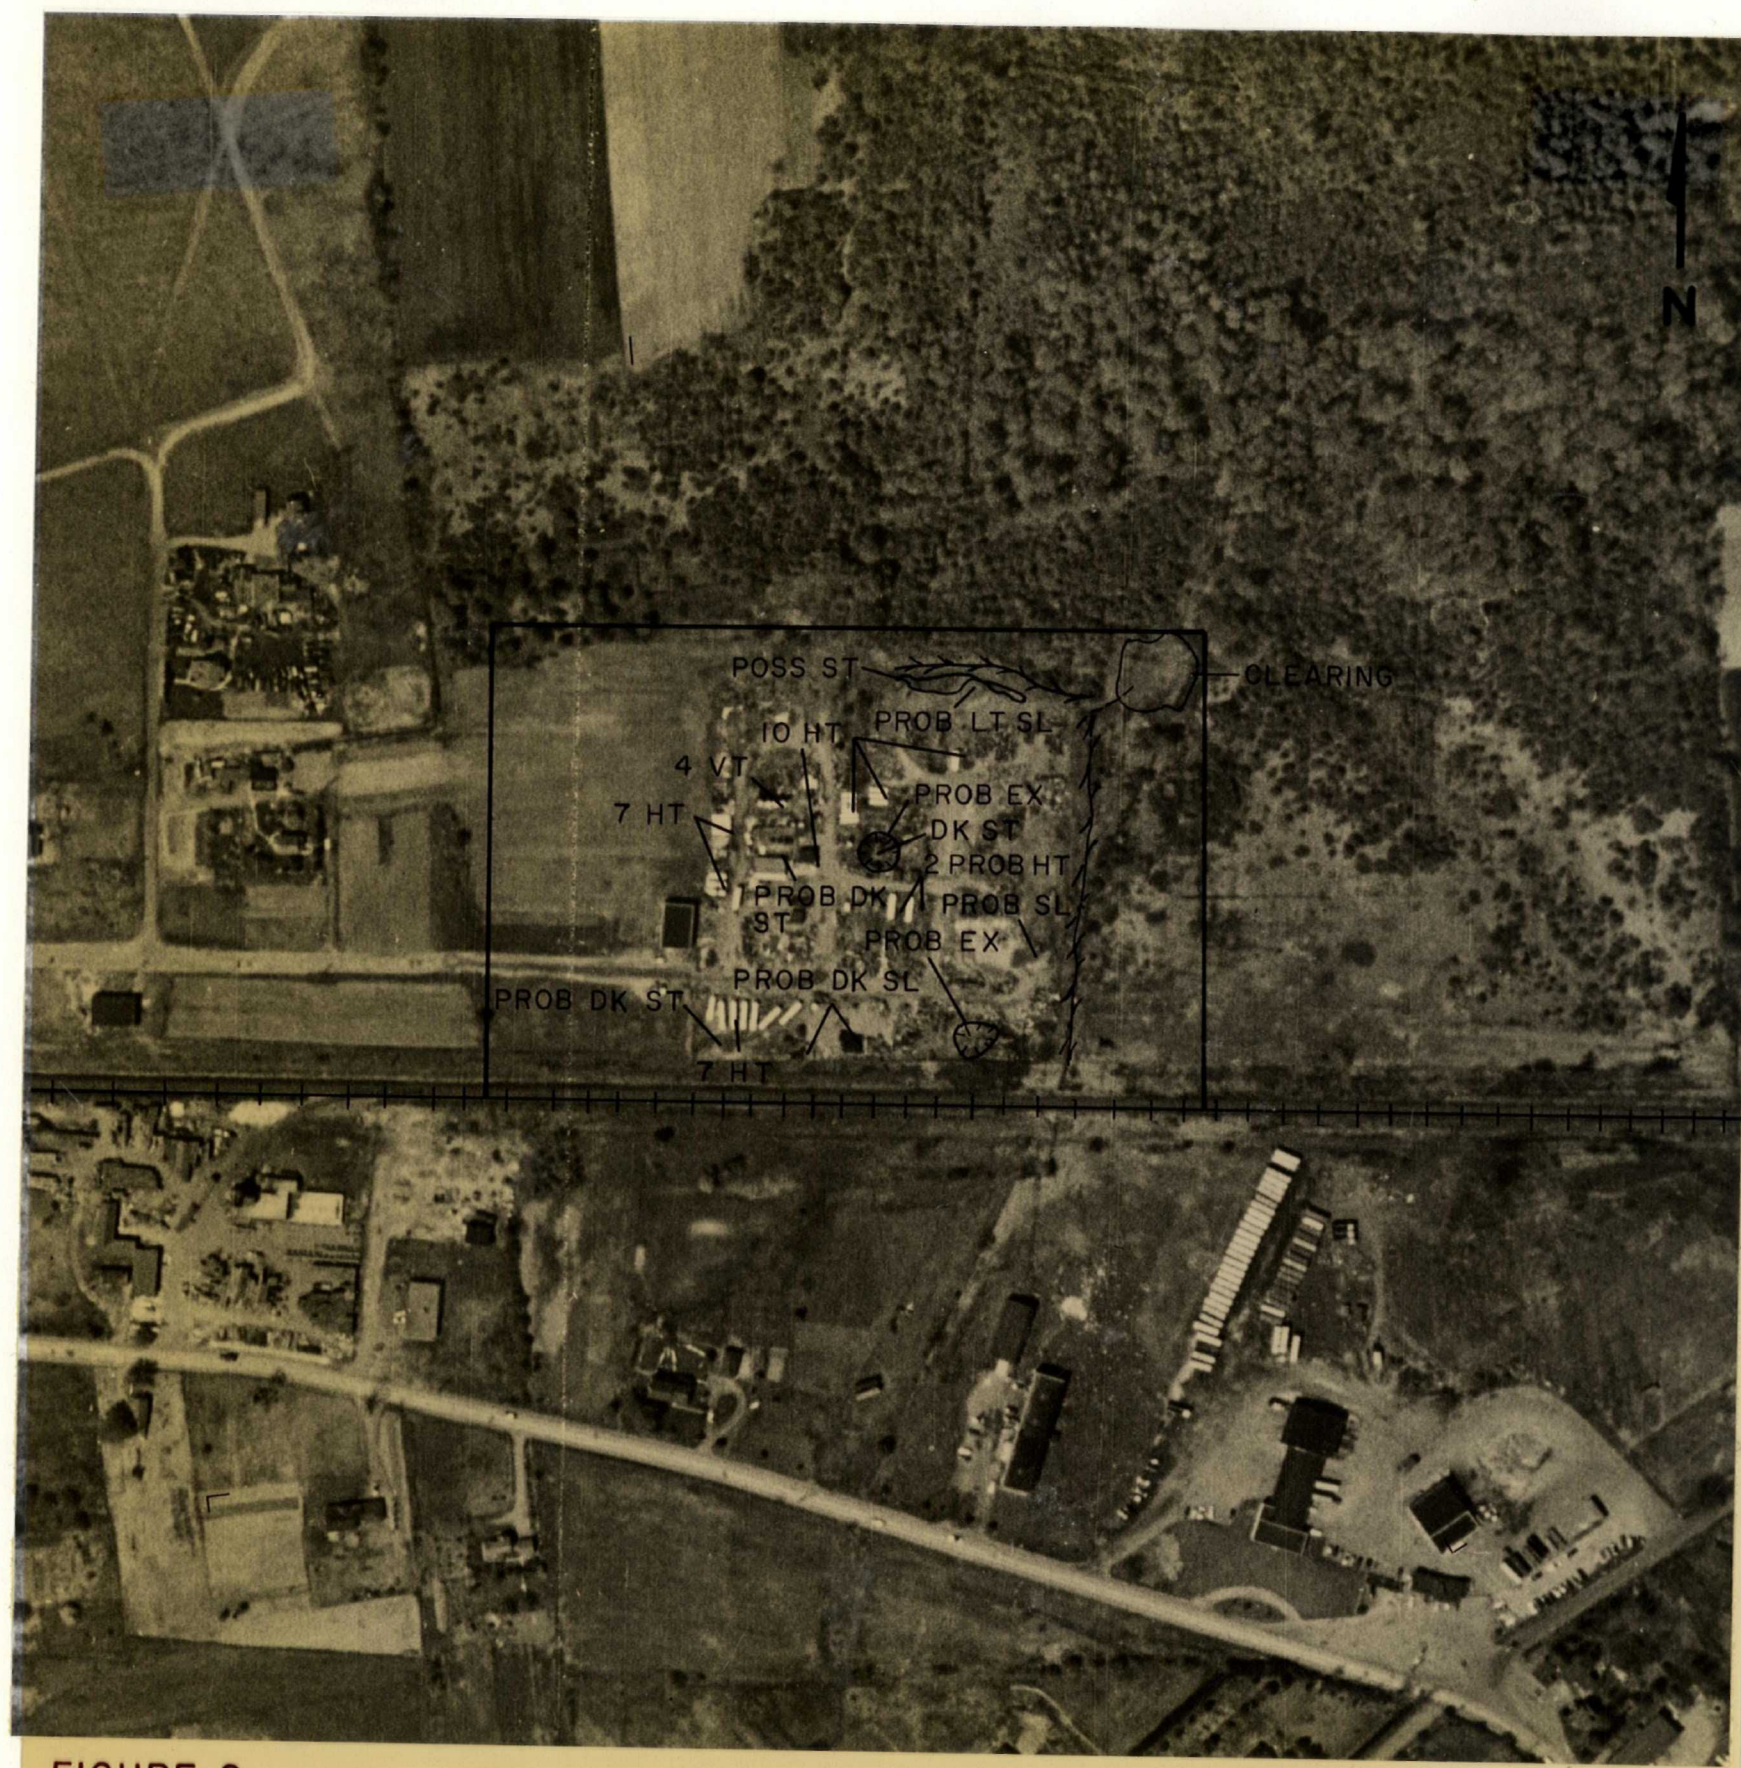
FIGURE 2
CHEMSOL SITE

The 1951 photography was not reproduced for this report, as the study area was still farmland. In 1957, the first year Chemsol appears on available photography, the site is bounded by railroad tracks to the south, farmland to the west, and wooded areas to the north and east. The site has already been active for a while and is crossed by a network of dirt roads. Numerous mounds of unknown materials and possible refuse can be seen throughout the site and are not annotated. No evidence of waste burial is seen. Two probable shallow excavated (EX) areas were found, one in the center of the site which exhibits dark-toned (DK) staining (ST), and one along the southern boundary of the site in the vicinity of a drum storage area.* In addition to the drum storage area, three additional areas of concern are mentioned in collateral information: a containment area* in the southeast corner of the study area, a trench* in the southeast quadrant and a small dump area* in the northeast corner of the study area. The trench mentioned in collateral information cannot be seen in the vicinity where it is described as being on any of the photography analyzed and will not be referred to again in this report. The containment area has not yet been constructed.

A clearing in the northeast corner of the study area has an access road leading to it from the site. This clearing is in the general vicinity of the small dump area.* The berm in the northeast corner has a break in it, giving access to the clearing as well as allowing runoff from the site to pass through. Possible dark-toned staining is found along the berm. Probable light-toned (LT) standing liquid (SL) in the northeast quadrant suggests areas where runoff temporarily collects.

Areas of probable dark-toned standing liquid are located along the southern edge and in the southeast quadrant.

Horizontal tanks (HT), vertical tanks (VT), and probable horizontal tanks are found at various points on the site. Dark-toned stains can be seen along the southern edge of the seven tanks in the lower southwest quadrant through 1967. The same locations are used for tank storage throughout the study period. They will continue to be annotated but are discussed only when significant changes occur. Numerical annotations on the overlays describe the number of tanks at that location.

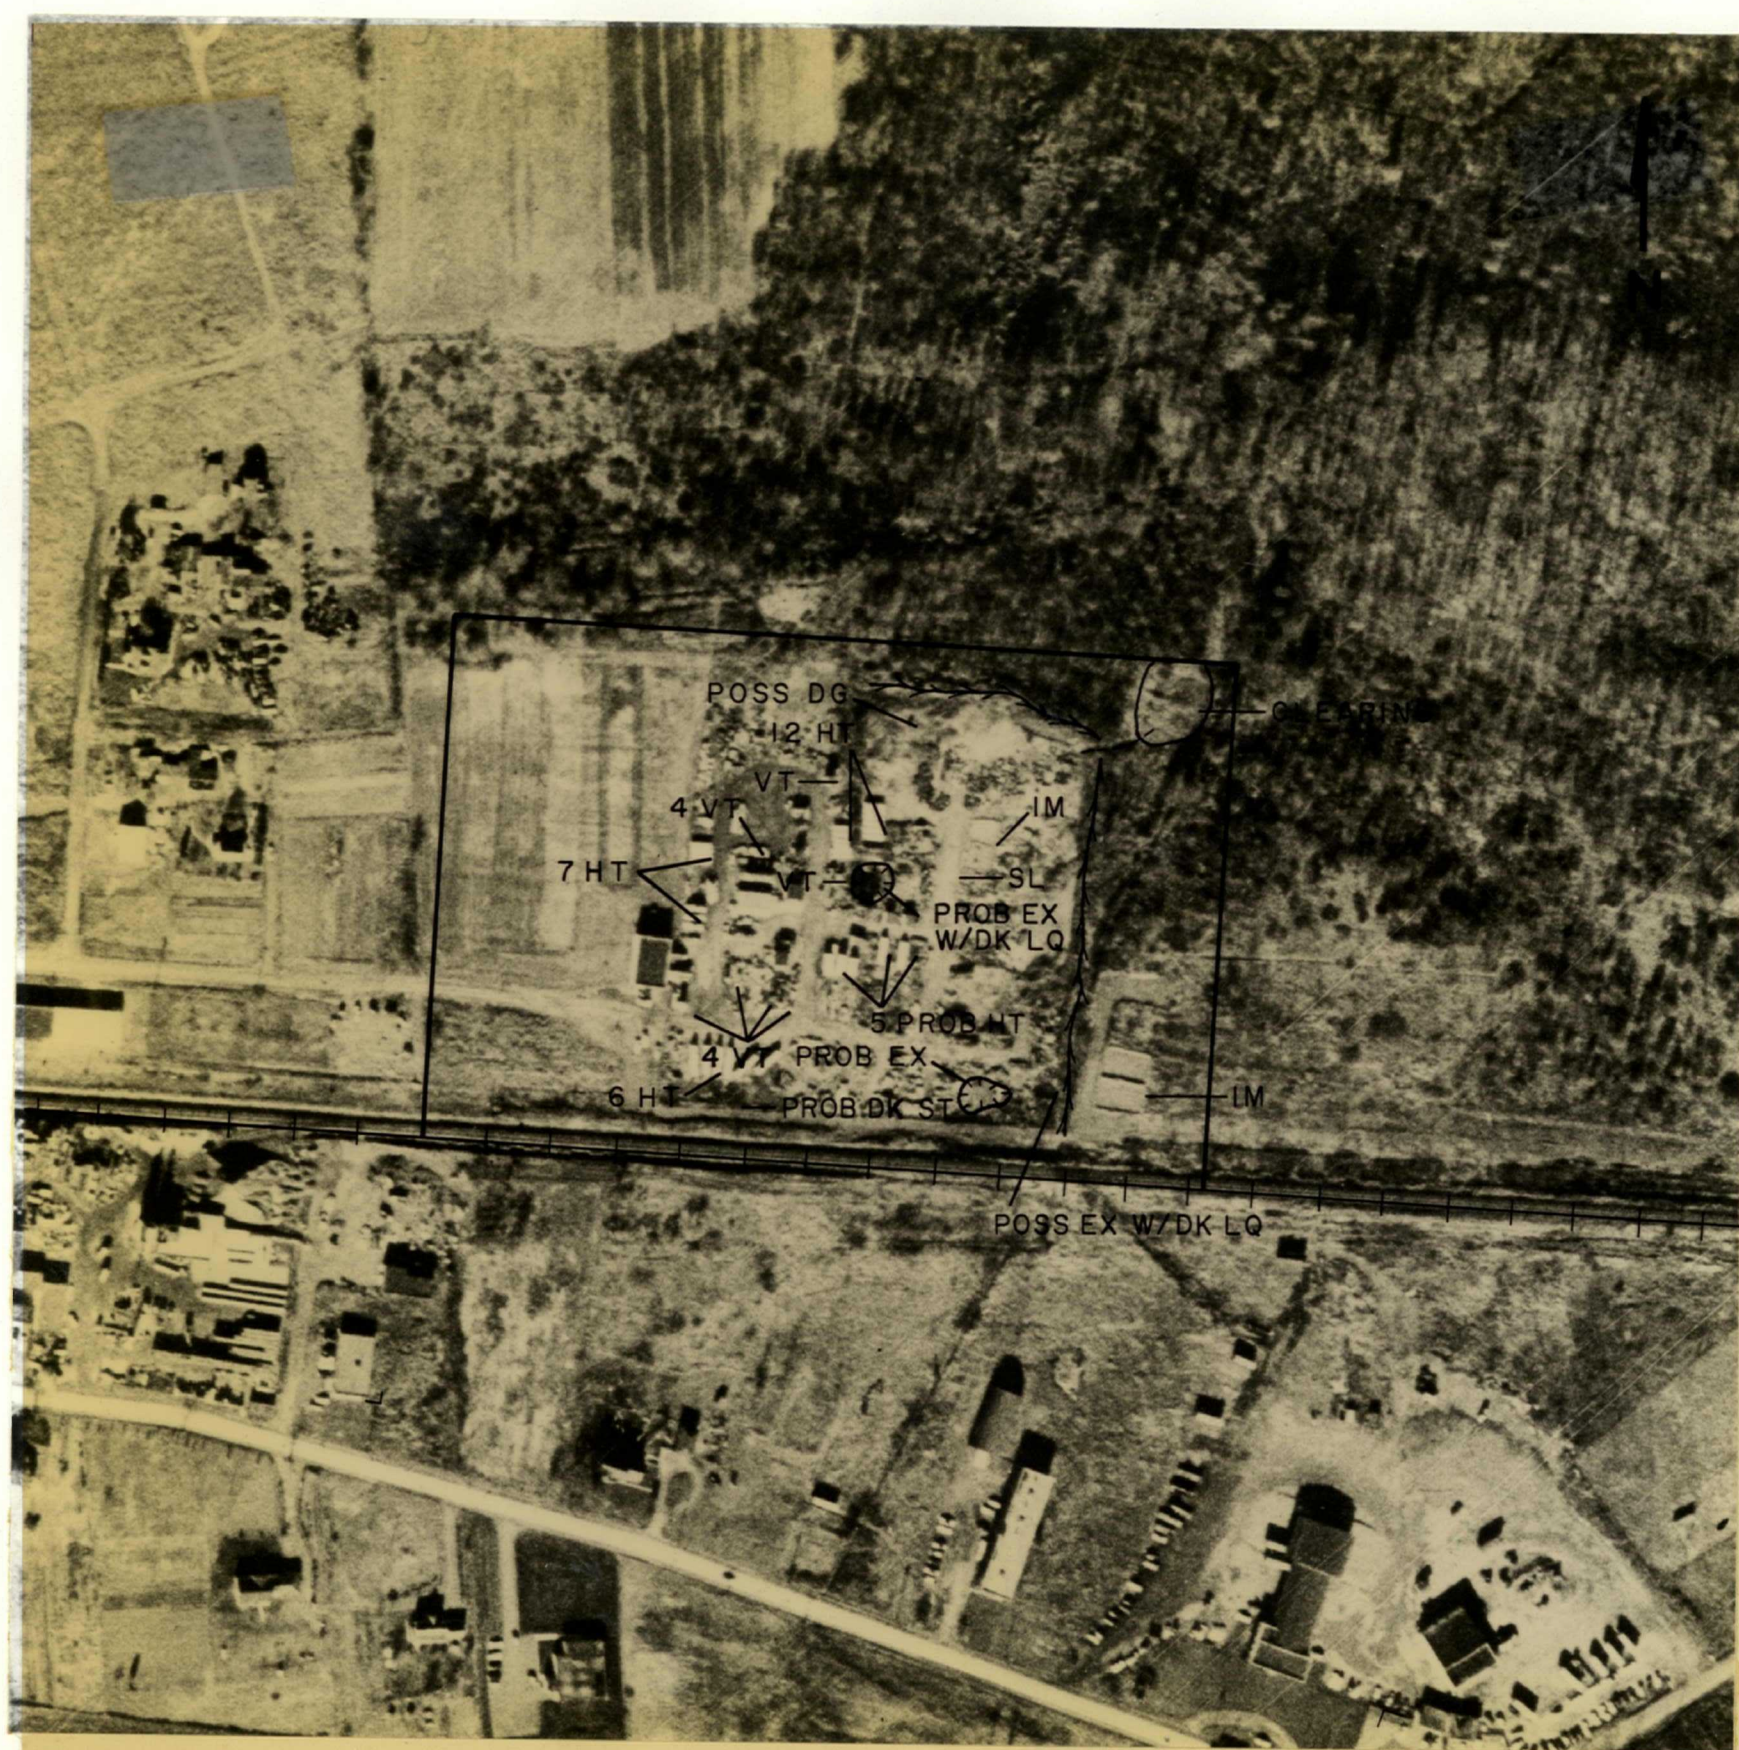
FIGURE 3
CHEMSOL SITE

The probable excavated area along the southern boundary appears essentially unchanged. Just east of this is a smaller possible excavation with dark-toned liquid (IQ). Several small piles of possible refuse (not annotated) are found in this area. Numerous other small mounds of unknown materials are still found throughout the site.

An impoundment (IM) has been constructed at the containment area* in the southeast corner of the study site. It is contained by a low berm and divided in half by a central berm. A dirt access road has been constructed parallel to the railroad tracks along the southern site boundary, leading to the impoundment. The even tone and texture across the surface of the impoundment suggests a possible layer of shallow liquid.

A second similarly shaped, somewhat smaller impoundment has been constructed in the northeast quadrant of the site. Four small unidentifiable objects appear in one section of the impoundment. Standing liquid can be seen near the impoundment's western side. An area of possible disturbed ground (DG) is found in the northeast quadrant, just below the berm.

The clearing in the vicinity of the small dump area* appears more vegetated; no activity can be seen there.

Five horizontal tanks have been added since 1957, and one horizontal tank has been removed. Approximately six more vertical tanks have been added.

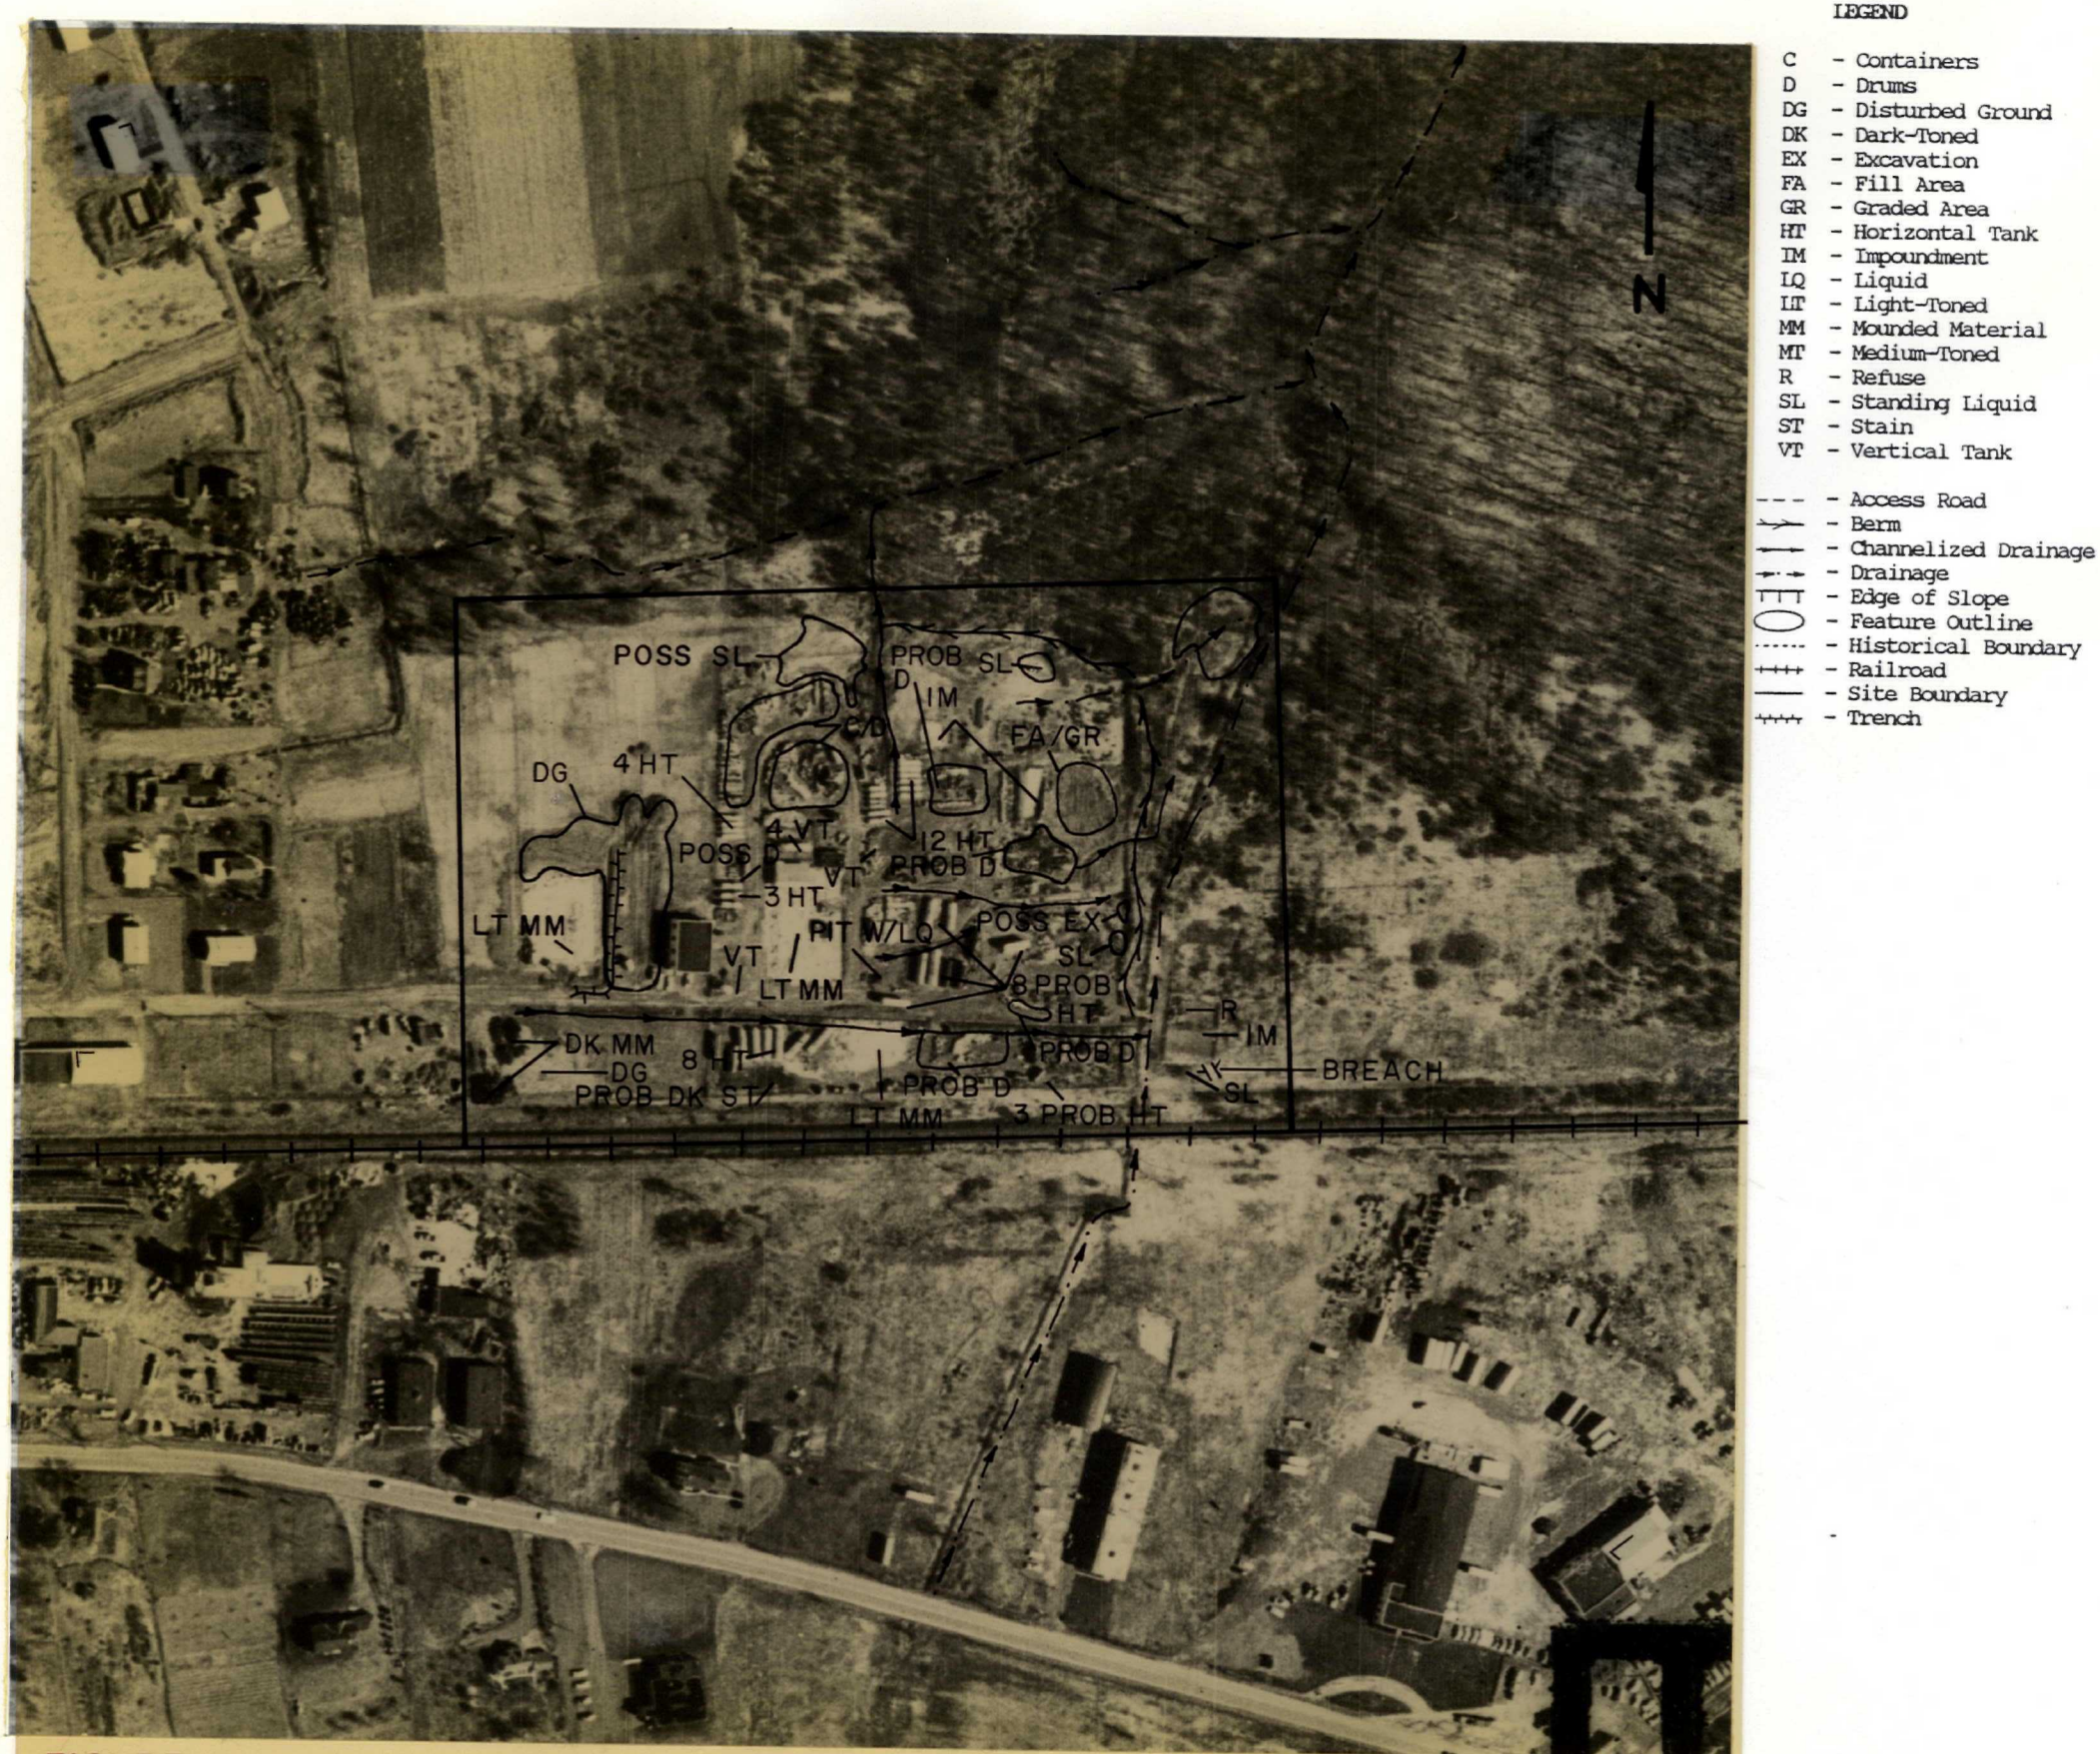
APRIL 20, 1961 (FIGURE 4)

Probable drums (D) can be seen in the vicinity of the drum storage area.* Dark objects (not annotated), possibly containers smaller than a drum, are scattered haphazardly in the southeast corner of this area. Three probable horizontal tanks have also been placed in this area. The probable excavated area has been filled, as has the one in the center of the site. A drainage channel has been dug along the north side of the drum storage area,* parallel to the southern site boundary and running the entire width of the site. It empties into the stream on the east side of the study area through a gap in the berm. Slightly north of this gap, also along the berm, a possible shallow excavation can be seen. At this location another drainage channel ends and standing liquid is seen. At the other end of this channel, still in the southeast quadrant, is a pit with liquid.

A mound of light-toned, medium-textured material (MM) has been deposited to the west of this area. Two other mounds of what appears to be the same material have also been deposited within the site. One, measuring 130 feet long by 100 feet wide, is located in the south central section of the site, and the other, measuring 100 feet by 90 feet, is located on the west side of the site. Two mounds of an unidentifiable dark-toned material are seen in the southwest corner of the site, partially covering an area of disturbed ground.

The impoundment at the containment area* has developed a breach in one berm. The only apparent contents are mounded refuse (R). Standing liquid is seen just outside its southwest side. The impoundment in the northeast quadrant has been restructured from two square sections into two rectangular compartments. The eastern one holds a light-toned liquid and the western one holds a dark-toned liquid. Probable drums, some arranged in rows and some apparently discarded, can be seen west and south of this impoundment. Dark objects (not annotated), possibly containers smaller than a drum, are mixed with the drums south of the impoundment as well as in the northeast corner. Another small square impoundment has been constructed to the northwest of this, and holds a light-toned liquid. In the same quadrant, near the eastern berm, a graded (GR) fill area (FA) can be seen. There is no indication of what might have been buried in this area.

The former clearing, referred to as a small dump area,* shows no sign of activity and is continuing to revegetate.

In addition to the probable drums seen in the eastern half of the site, a mixture of neatly arranged drums and containers (C) are located along both sides of the access road in the northwest quadrant. Just north of these is an area of possible dark-toned standing liquid contained by a berm.

Disturbed ground and a trench can be seen just west of the building in the southwest quadrant. Vertical tanks appear in the same areas as in 1958.

Possible refuse (not annotated) continues to be seen at numerous points around the site.

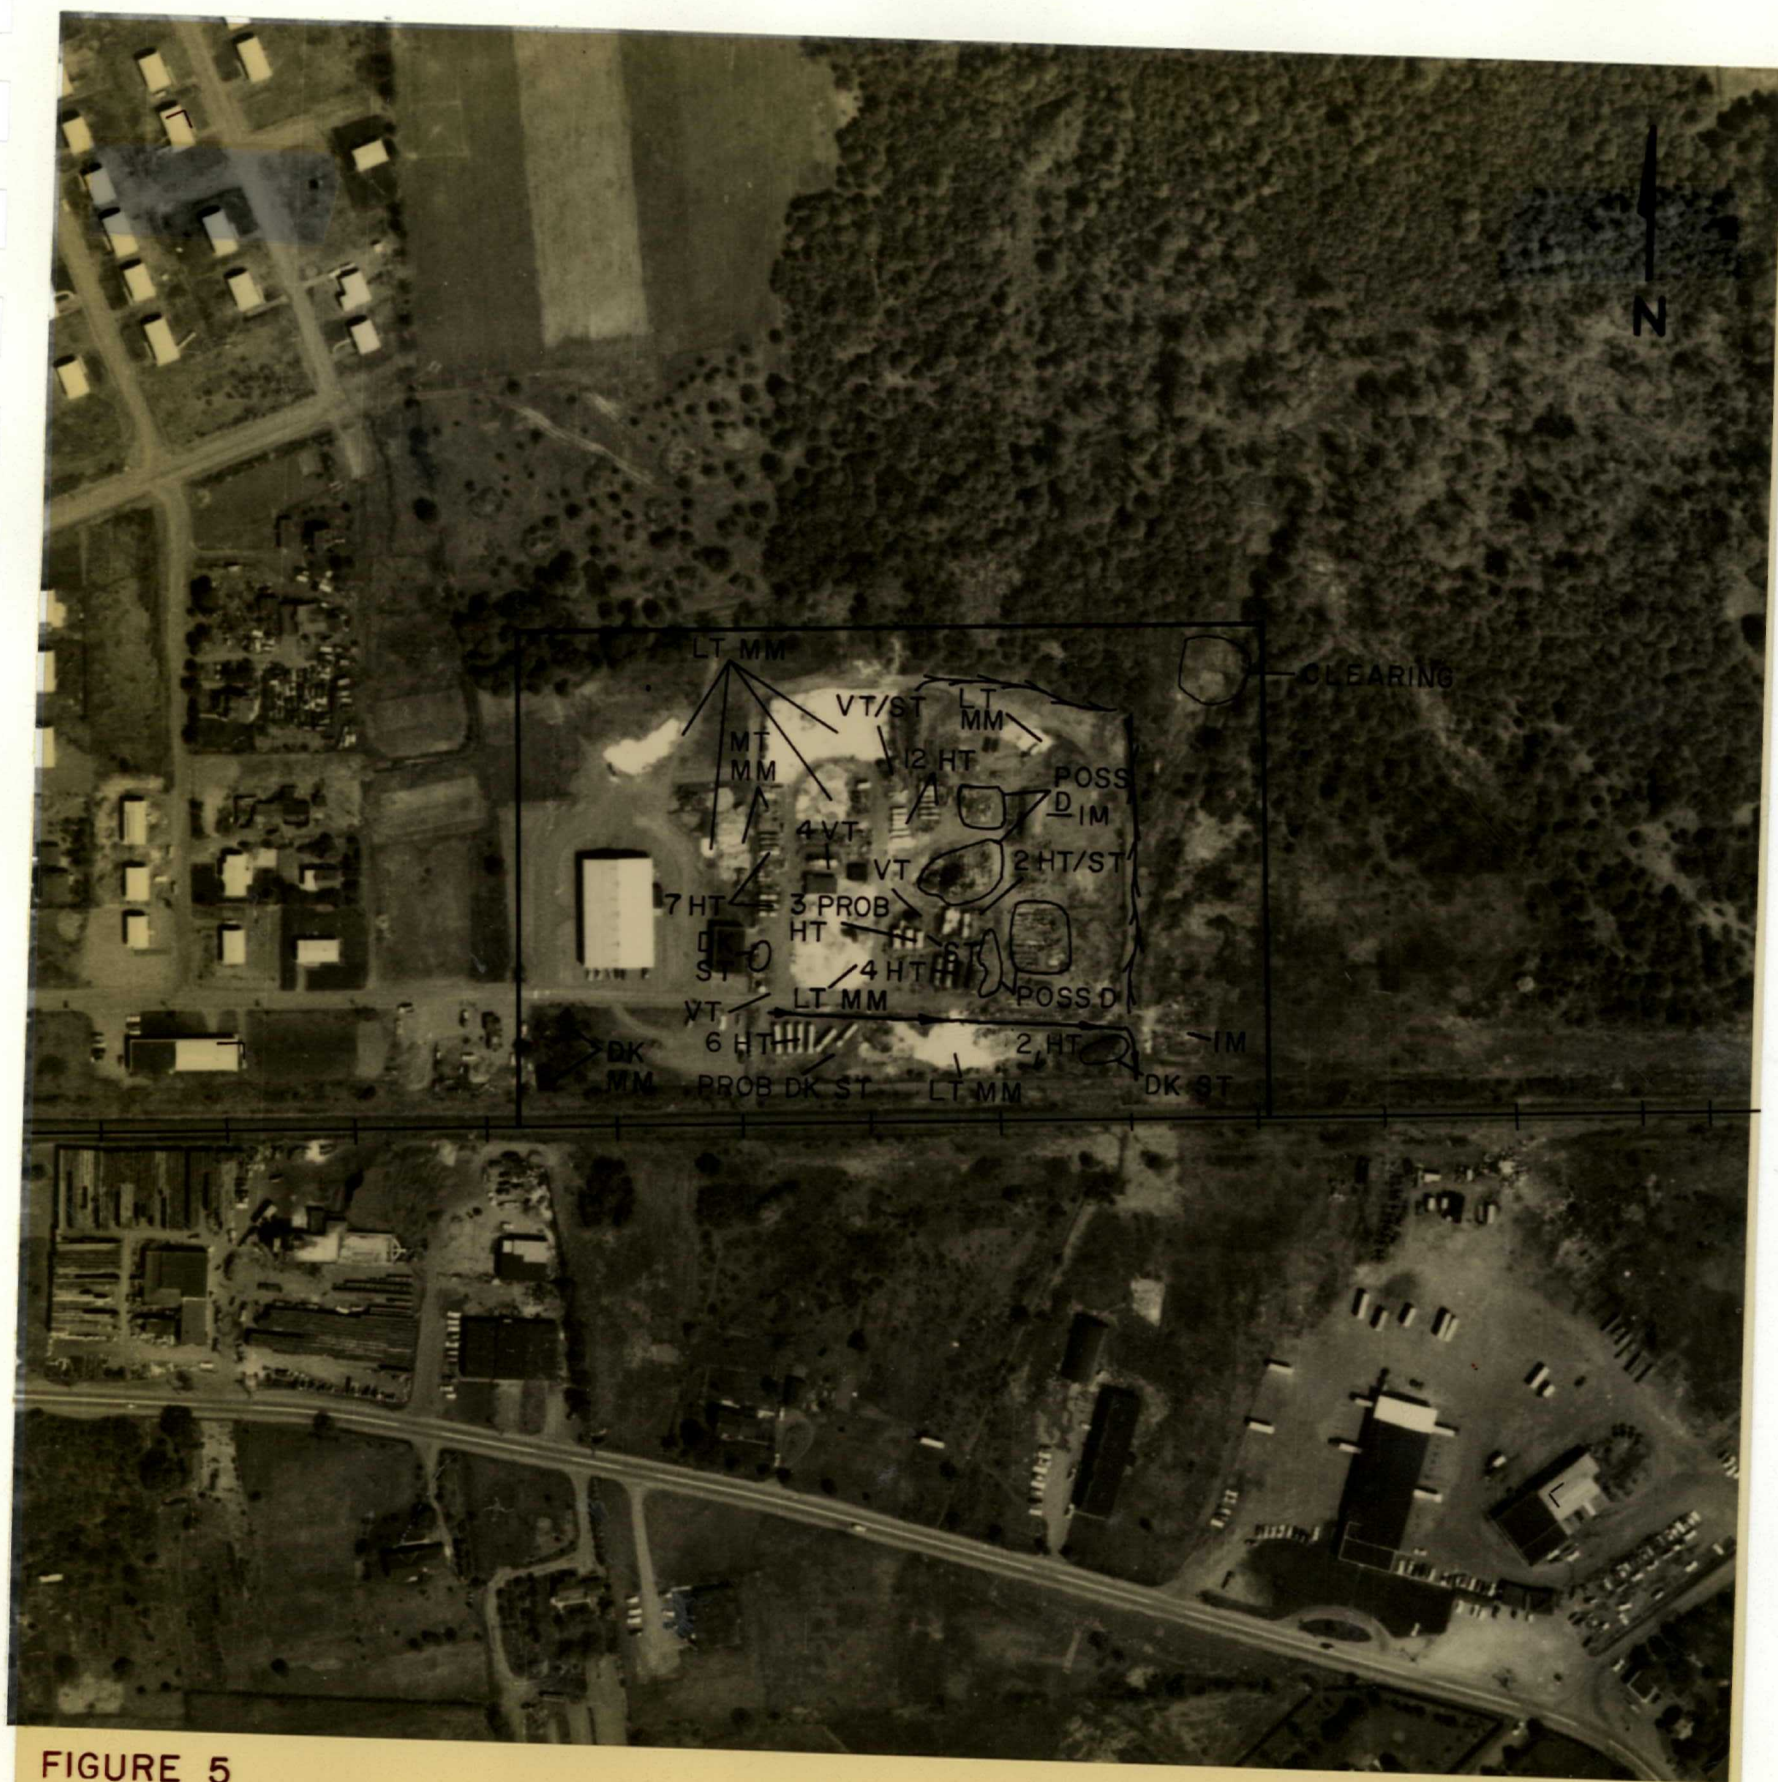
FIGURE 5
CHEMSOL SITE

The drum storage area* now contains two horizontal tanks. The possible drums have been removed. The mound of light-toned material has spread out somewhat over a section of the drum storage area.* The original section of the mound has become multi-toned, possibly due to revegetation, and reduced in height. Part of the mound extends into the drainage channel. Staining is noted around a vertical tank to the west, as well as around the horizontal tanks in the southeast quadrant, near the center of the site, and also associated with a vertical tank outside a building in the southwest quadrant. Dark staining also appears in the southeast corner of the site. A building has been constructed on the site of the westernmost mound seen on 1961 coverage. The disturbed ground between the building and the former mound has been filled and leveled. The dark mounded material just south of this building is still present. Five other light-toned mounds of varying size are found in the study area.

The berm surrounding the impoundment at the containment area* has undergone further decay. A few small unidentifiable objects can be seen in it. The impoundment with the parallel trench in the northeast quadrant is still present and is filled with light-toned liquid. The smaller impoundment to the northwest has been filled; however, the area still appears wet or stained (not annotated).

The clearing in what is referred to as the small dump area* shows no sign of activity.

Possible drums are concentrated in the northeast and southeast quadrants, towards the center of the site. A mound of light-toned material and a mound of medium-toned (MT) material now cover much of the previous area of drums and containers in the northwest quadrant. The dark-toned possible

containers in the northeast and southeast corners of the site are no longer present, and far fewer haphazardly scattered possible drums are seen. The berm running along the east side of the site has been renovated. Two gaps remain in it, one across from the southeastern impoundment and one allowing access to the clearing.

Possible refuse (not annotated) continues to be seen at various points around the site.

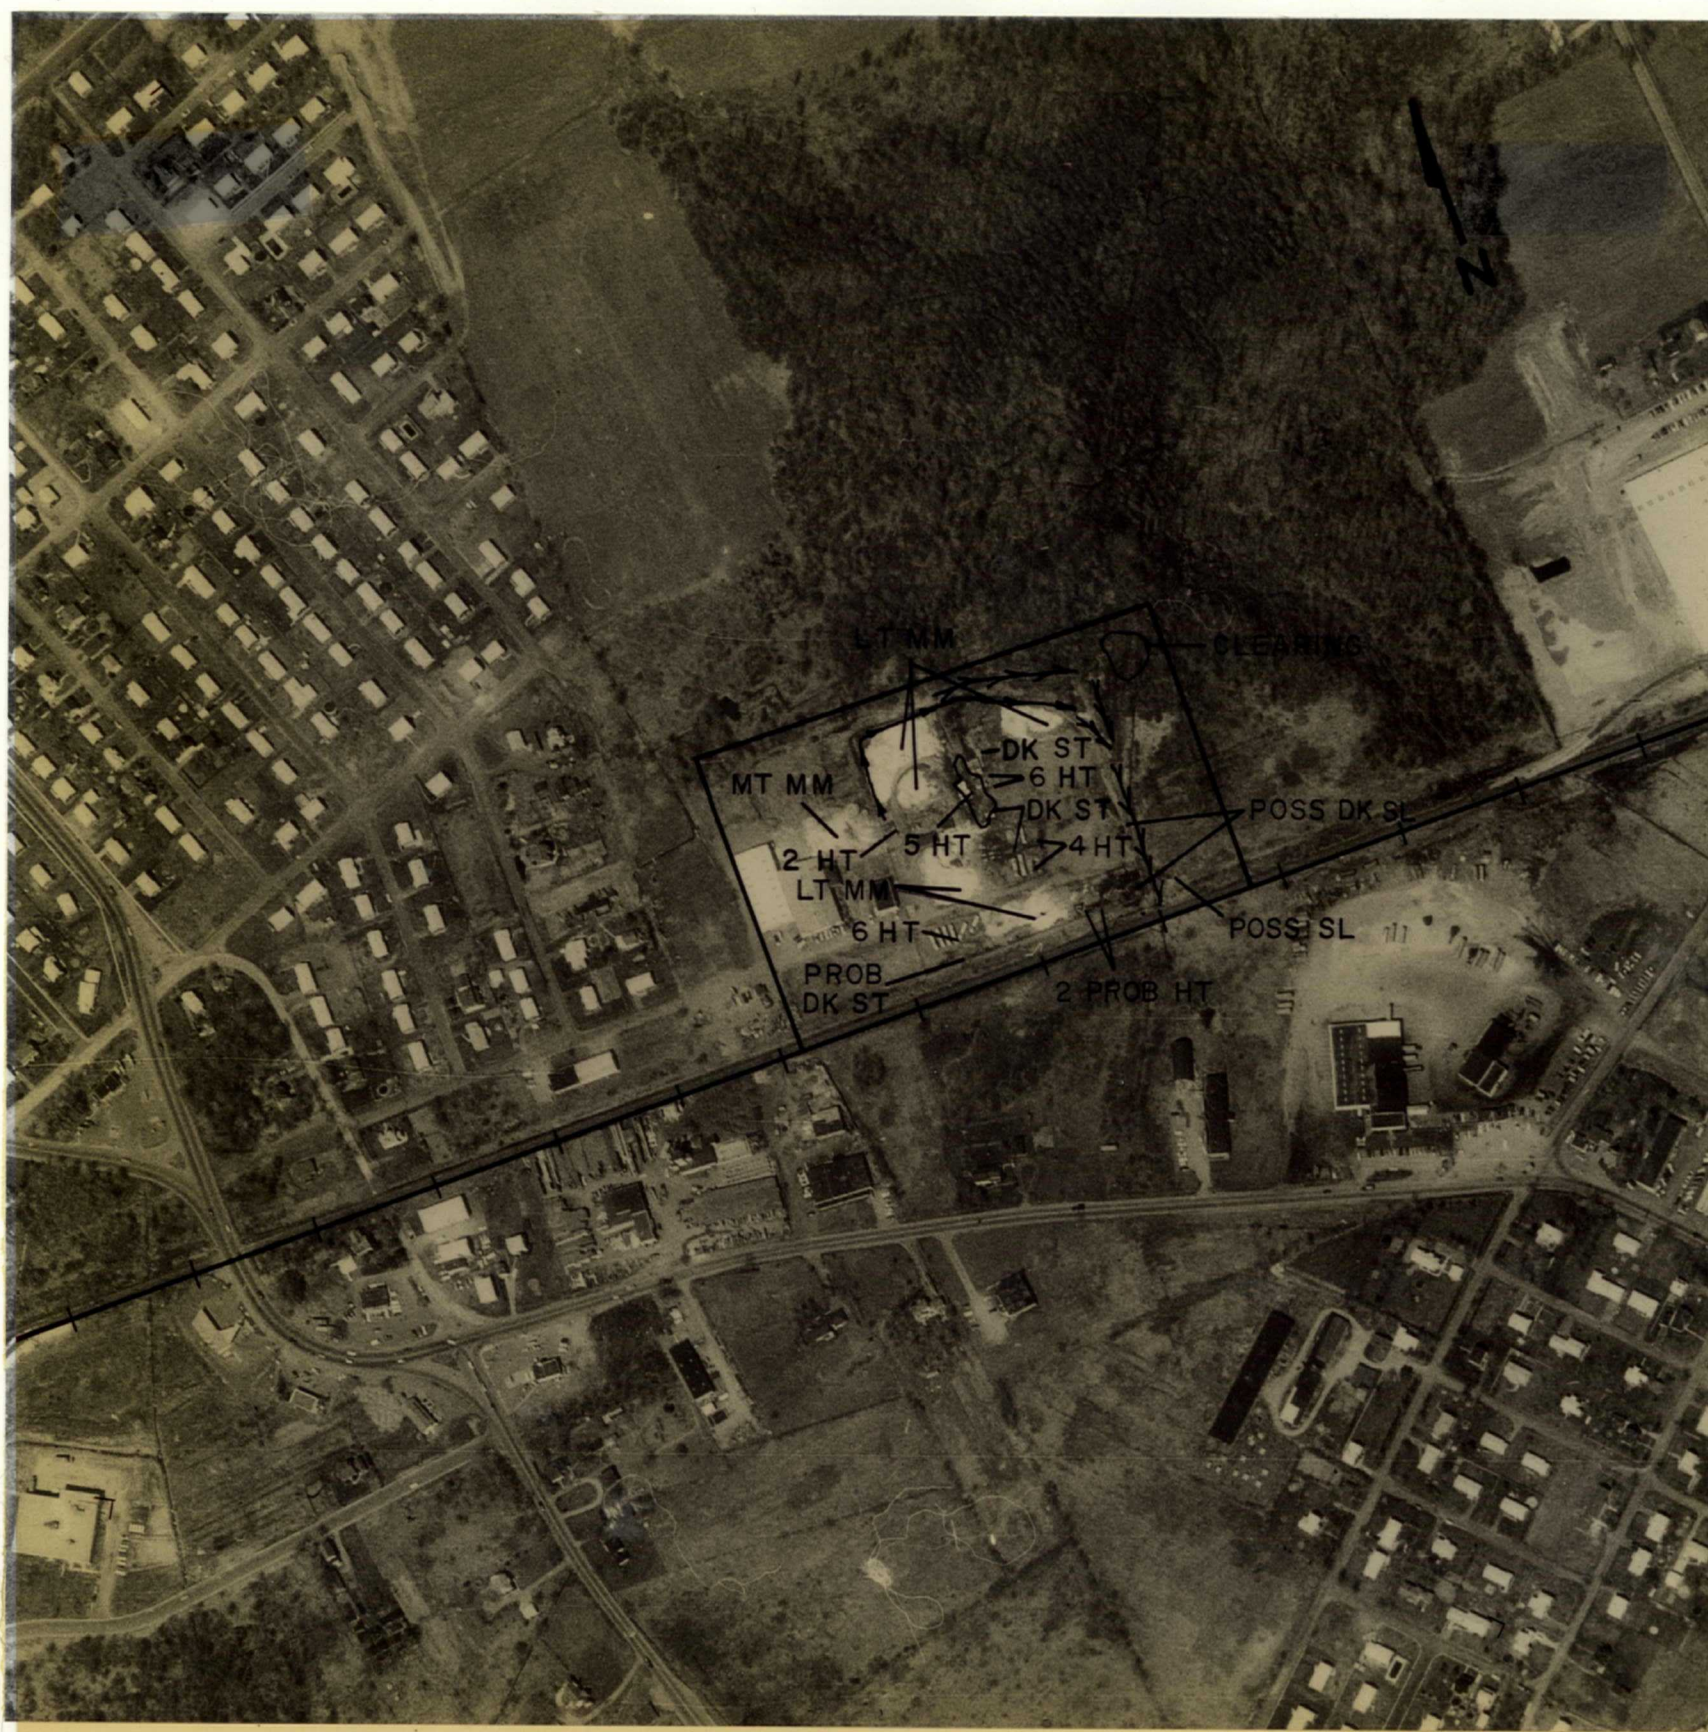
FIGURE 6
CHEMSOL SITE

According to collateral data, Chemsol ceased operations in 1964.

The area referred to as a drum storage area* has been cleared of all identifiable objects except for the two probable horizontal tanks. Possible dark-toned standing liquid can be seen near the berm in this area.

The berms around the impoundment at the containment area* have been leveled, with only a shallow depression and possible standing liquid remaining. The northwesternmost mound of light-toned material has been removed. The other five remain, as does the medium-toned material. Material from the westernmost mound has shifted to the west. The dark-toned mounds in the southwest corner are no longer present. Approximately 17 horizontal tanks remain in the center of the site, as do the 6 probable tanker trailers in the southwest corner. No vertical tanks can be seen. Staining is noted near all the horizontal tanks. A new drainage channel has been dug just inside the berm along the north side of the study area.

The clearing continues to revegetate and no sign of dumping activity is present. A small pool of possible dark-toned liquid can be seen along the berm in the southeast quadrant.

Very little refuse (not annotated) can be seen.

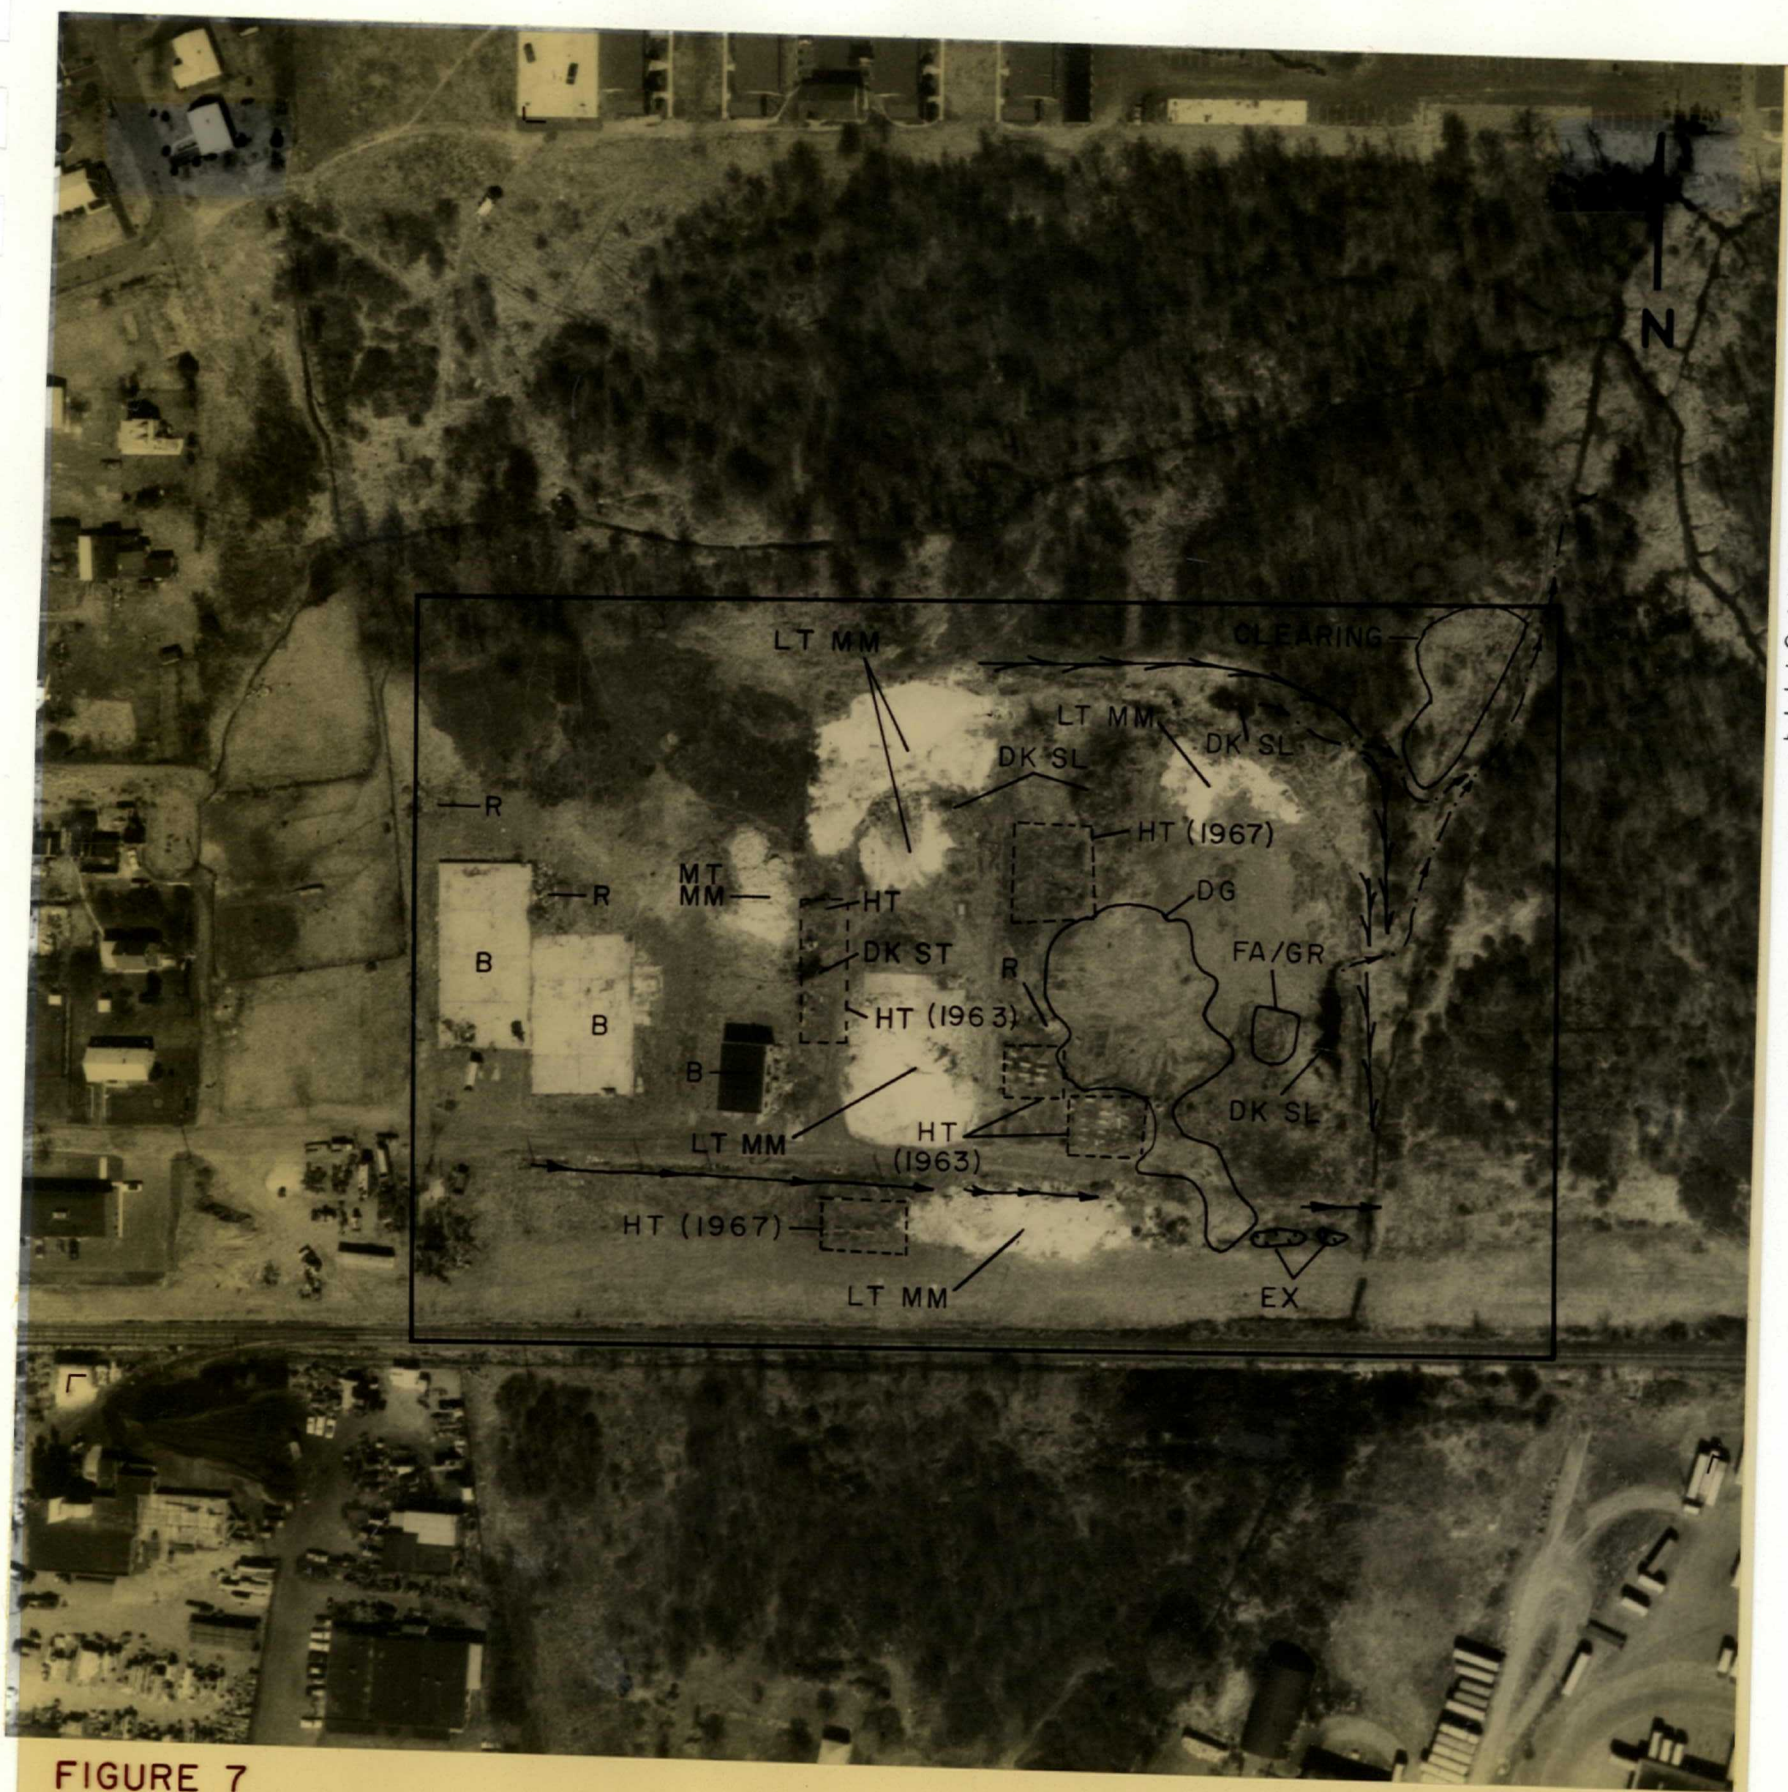
FIGURE 7
CHEMSOL SITE

Shallow excavations are visible in the drum storage area,* bordering the south side of the drainage channel. The drainage channel in this area has been partially filled. To the west the channel is mostly open with occasional small, unidentifiable light- and dark-toned objects (not annotated) along its bottom.

A shallow depression remains at the former impoundment* (not annotated).

Dark-toned standing liquid can be seen in the northeast corner of the site along the berm, and on the southeast side of the site, also along the berm. Overflow from both areas of standing liquid runs through breaks in the berm and flows by the east side of the clearing in the northeast corner, just beyond which it runs into a stream. No dumping is visible in the clearing. Dark-toned standing liquid can also be seen in the vicinity of where six horizontal tanks had been in 1967. In the northwest quadrant dark-toned standing liquid is seen between the two northernmost mounds of light-toned material.

Dark staining can be seen between the eastern building and the medium-toned mound in the southwest quadrant. The only remaining horizontal tank visible on the site is just north of this stain.

Light-toned and medium-toned mounded material is found in the same locations as in 1967.

Disturbed ground can be seen over much of the southeast quadrant, particularly towards the center of the site. A possible graded fill area can be seen just west of the dark-toned standing liquid.

The two western buildings have been razed, with only the concrete foundations remaining. Refuse is piled against one foundation wall. Further refuse is seen northwest of the foundation and in the southeast quadrant near the center of the site.
